GROUP	MODEL
ELE	2018-2019MY Niro (DE EV/PHEV)
NUMBER	DATE
186	September 2019

TECHNICAL SERVICE BULLETIN

SERVICE ACTION: ELECTRIC WATER PUMP

INSPECTION AND REPAIR (SA394)

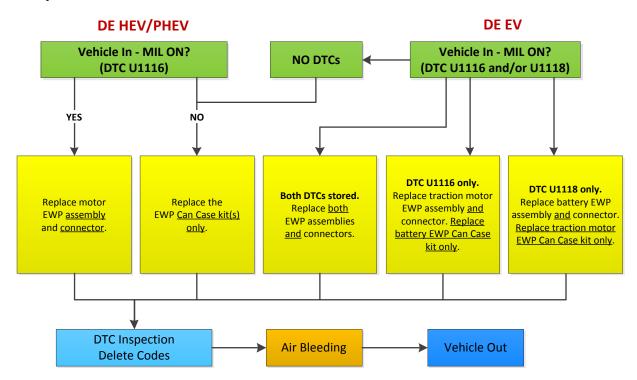
EWP Repair Flowchart:

This bulletin provides the procedure to inspect and repair the Electric Water Pump(s) (EWP) on some 2018-2019MY Niro (DE) HEV, PHEV, and EV vehicles produced between November 24, 2018 through January 30, 2019, which may exhibit a MIL ON (DTC U1116 and/or U1118) due to a coolant leak from the EWP Can Case. Follow the procedure in this bulletin to inspect and repair the EWP. Before conducting the procedure, verify that the vehicle is included in the list of affected VINs.

Model	MIL ON	Repair Procedure		
(DE)	DTC U1116	Replace the hybrid motor EWP assembly and EWP connector.		
(HEV/PHEV)	NO DTCs	Replace the hybrid motor EWP Can Case kit only.		
	DTC U1116 and U1118	Replace the <u>both</u> the battery and traction motor EWP assemblies <u>and</u> EWP connectors.		
(DE)	DTC U1116	Replace the traction motor EWP assembly <u>and</u> EWP connector. Replace the battery EWP Can Case kit.		
(EV)	DTC U1118	Replace the battery EWP assembly <u>and</u> EWP connector. Replace the traction motor EWP Can Case kit.		
	NO DTCs	Replace the traction motor <u>and</u> battery EWP <u>Can Case kits only</u> .
